Divisional Inquiry Report
815-11-01
iSail #20144

Vessel/Terminal Name: Nanaimo Harbour Terminal
Incident Type: Portion of trestle collapsed/Vehicle in water
Incident Date: 0315 hours August 12, 2011

Type of Incident: Portion of Trestle collapsed/Vehicle in water

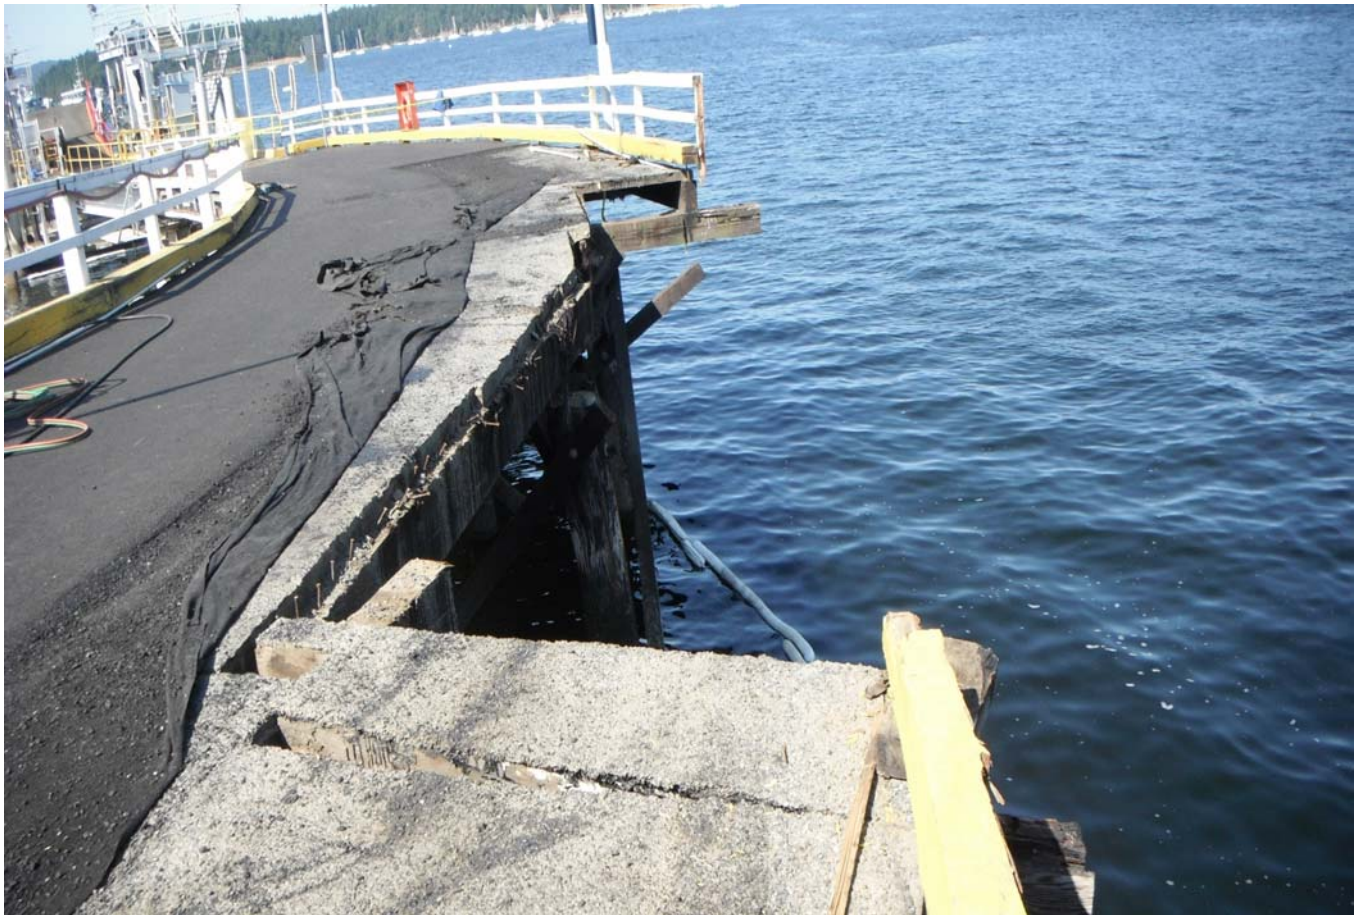
- BCF employees heard the sound of wood breaking and observed the asphalt truck near the bent 3 area falling backwards. As the truck fell portions of the stringers and planks on the pedestrian side of the trestle broke away and fell into the water. The trestle sustained damage between bents 3 and 5. The asphalt spreader unit on the trestle remained near bent 5 and was partially hanging over the trestle. The asphalt truck landed on its roof in the water with the front of the truck facing towards shore.

Close up view of damage to trestle after clean up

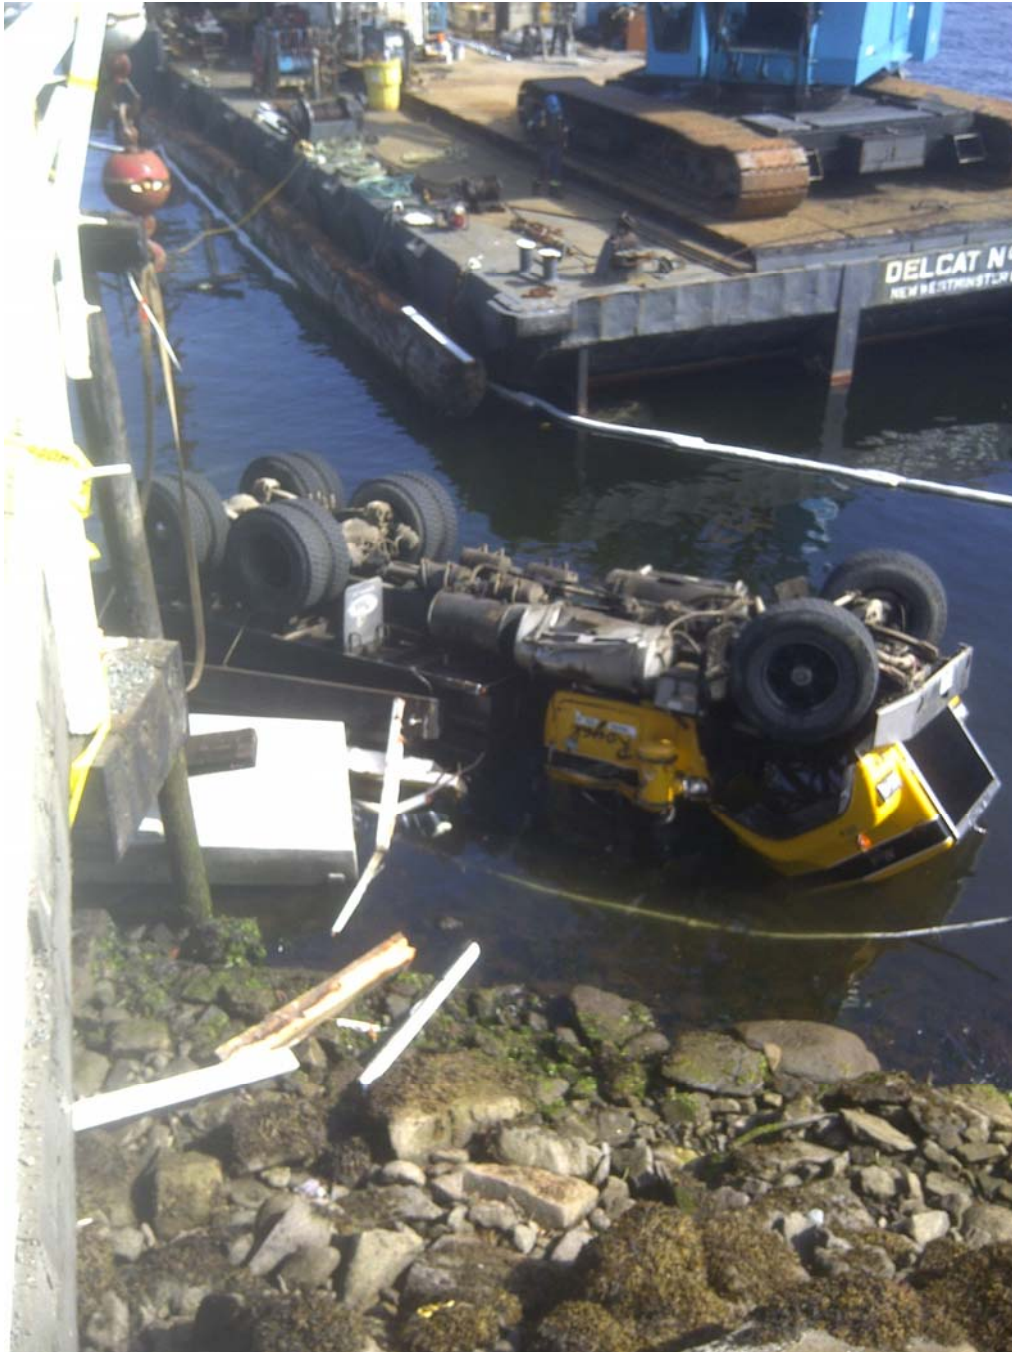
- Co-owner 2 in the asphalt truck exited by the open passenger window and was on the shore. Co-owner 2 advised he was not seriously injured and had a small cut on one hand. The tide was quite high at the time of the accident and it is believed that this prevented the driver from receiving serious injury.

View of asphalt truck in water
