# Divisional Inquiry Report # 815-09-01

Vessel/Terminal Name: Spirit of Vancouver Island  
Incident Type: Fire – Auxiliary Machinery Space  
Incident Date: 9<sup>th</sup> Oct 2009

**Date of Incident:** 9<sup>th</sup> Oct 2009  
**Location of Incident:** Berth 1 – Swartz Bay Terminal  
**Type of Incident:** Fire – Auxiliary Machinery Space

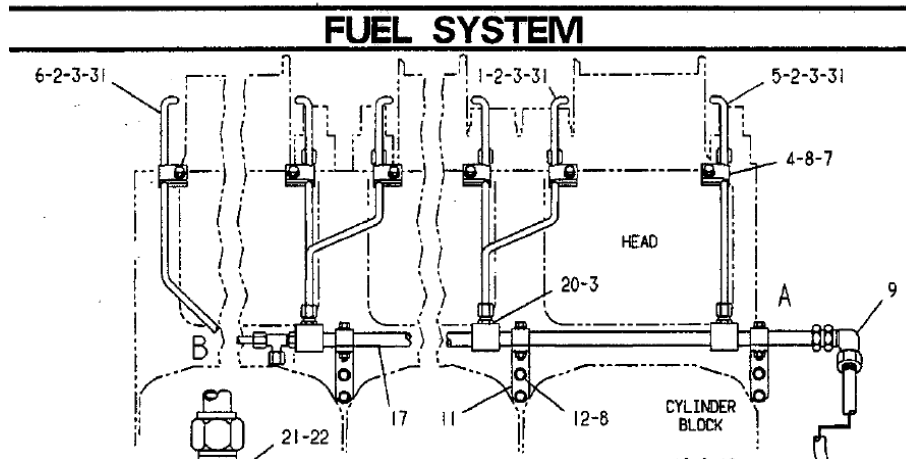
### Engine Fuel Supply

The fuel supply tube is shown in the arrangement below as third tube from the right hand side.

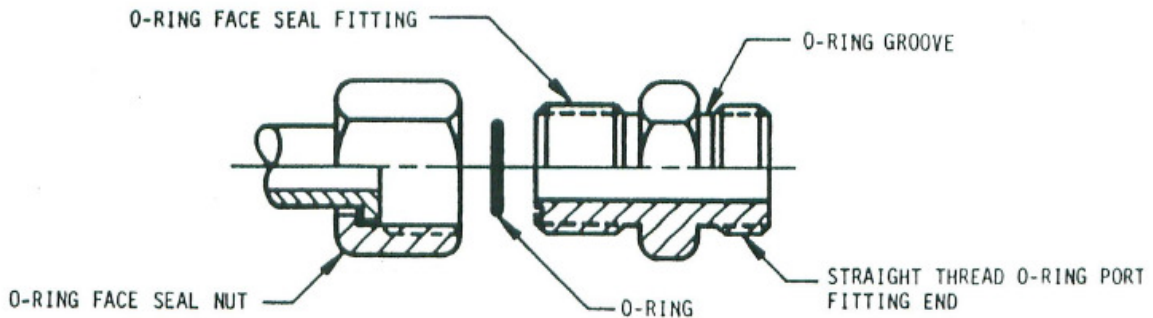
### Fuel Tube Fitting Style

4.1 (a) Loss of containment at fuel supply tube fitting into cylinder head #2 (engine free-end side).

Cause: O-ring face seal (ORFS) fitting nut backed off the fitting threads. (See Appendix A)

Root Cause: Incorrect assembly of the compression fitting. No seal ring fitted. The nut machine thread holding force is solely dependent on a hard metal to metal compression without the additional resilient strain of seal ring crush.

The fitting is an O-ring face seal design shown in the diagram below. The same fitting type is found at both ends of the fuel tube. No O-ring was found in the fitting or in the near vicinity on the engine upon inspection after the incident.

(i) **Recommendation #1:** Examine all the same fuel supply fittings on the 3606 Caterpillar engine for presence and condition of the O-ring seal.

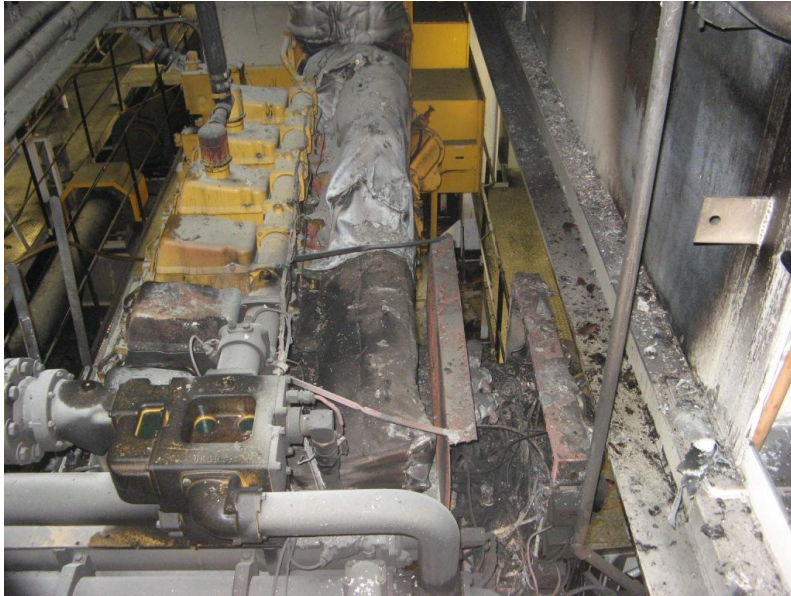
### Pic-1 Standby Generator

Top deck view of fire damage to the 3606 Caterpillar Standby Generator.

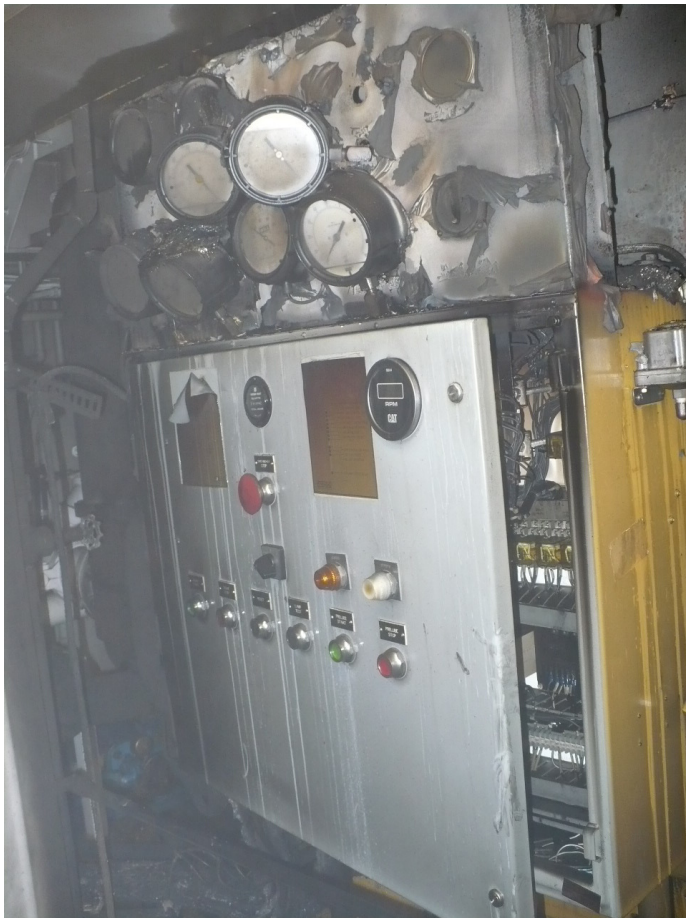
### Pic-2 Generator Control Panel

Extensive fire, heat and smoke damage to the panel components, cabling and gauges.

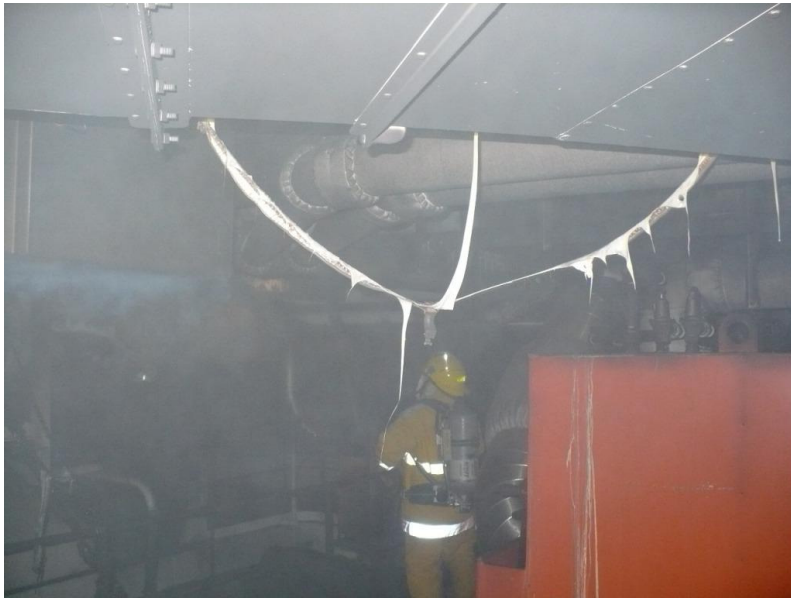
### **Pic-3 Auxiliary Machinery Space Mezzanine Deck**

Extensive heat and smoke damage on the mezzanine deck of the Auxiliary Machinery Space.

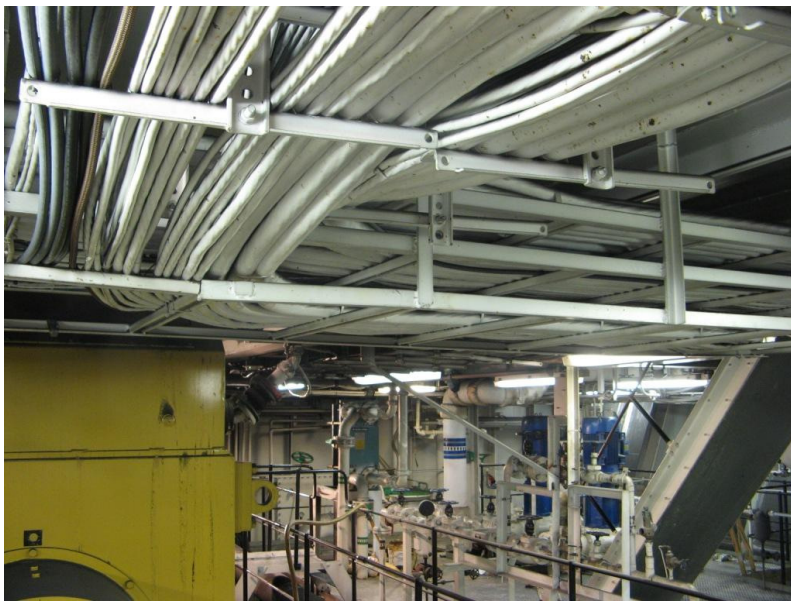
### **Pic-4 Auxiliary Machinery Space Grating Deck**

Cause: Fire and heat damage to control cabling in wireways adjacent to the SG.

Fire, heat and smoke damage is much more localized on the grating deck level. The electrical end of the generator is relatively clean.

The wire raceways through the compartment pass to the outboard side of the SG. Cabling in these wireways suffered damage near the forward end of the SG.

(i) **Recommendation #4:** Control cabling to be re-routed away from fuel burning equipment.

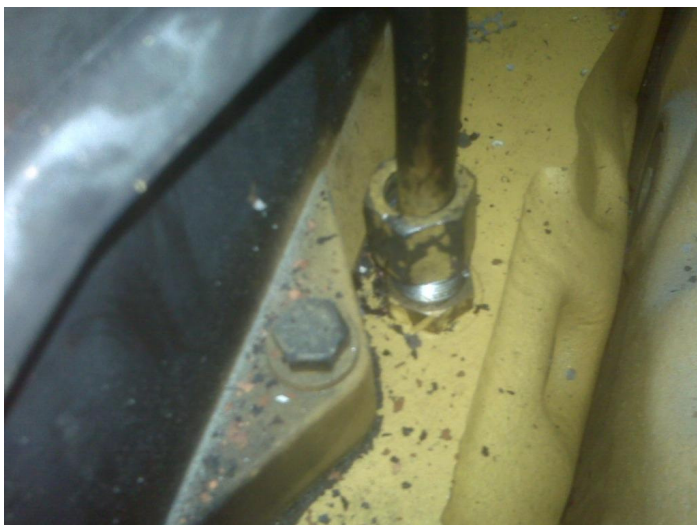
### **Pic-5 Found condition of the fuel tube compression fitting**

- e) On the morning of the fire, engine vibration overcame the remaining joint energy in the fitting and the nut became loose on the machine threads. Vibration was sufficient to turn the nut up the threads in a short period of time. Once the face seal was fully parted, mass fuel flow from the joint could be as much as several kilograms per minute, providing ample energy for the intense localized fuel fire.

The nut was found to be completely backed of the fitting threads.

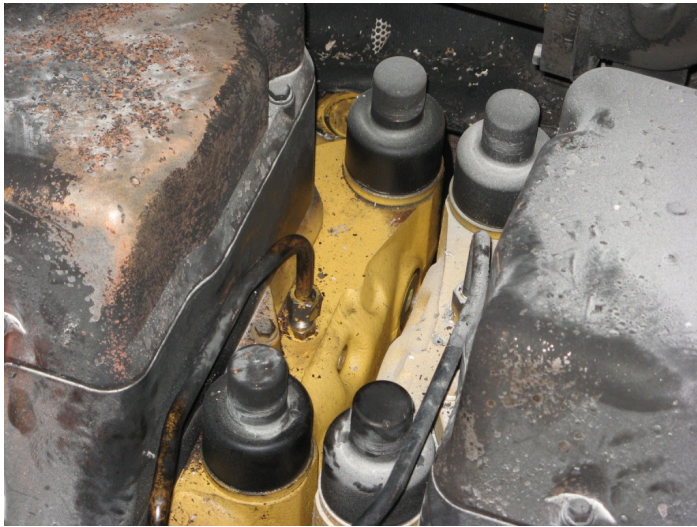
### **Pic-6 Cylinder Head #2 (engine free-end)**

The vicinity of the fuel leak was found clean, believed to be the result of a washing action from the fuel spray pattern (down and radial).

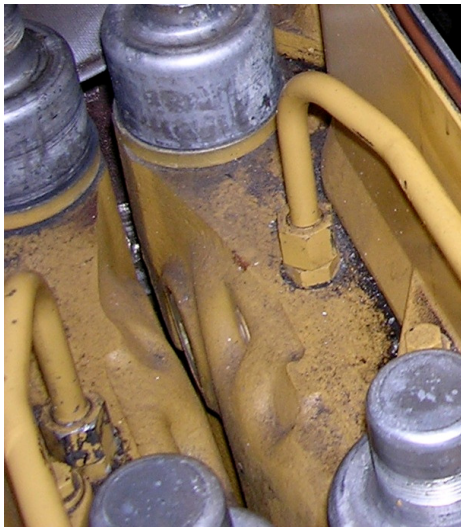
### **Pic-7 Feb 2009 Nut Condition**

- c) Tool markings on the failed end of fuel tube suggest that it was worked more often than the opposite end, i.e., for reasons other than removing or refitting the fuel tube, such as tightening to stop a leak. This supposition, however, is not corroborated by work log records or by crew interviews.

During the February 2009 cam replacement job, the same fitting was captured in a photograph of the work. (See bottom left corner of image)

The working marks on the nut faces are evident in this photograph.
