Ro/Ro – P/S “NORTHERN SEA WOLF ”

GT 2,679 - Built 2001 - IMO 9212450

Vessel's tanks Condition Survey
At Piraeus, Greece

Survey Report

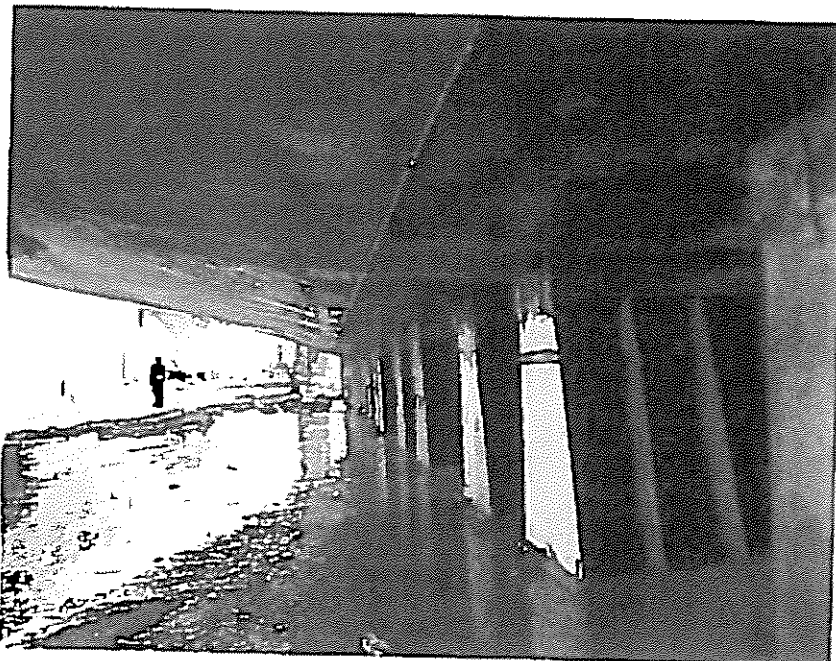
In addition to the above, light set-ins were also observed at the bottom in DBTank no. 3, approx. between frames 85 and 90, extending at the port side of keel plating. Longitudinals and brackets in way were also slightly distorted. The light set-ins were verified externally by inspection from the drydock. The nature of damage is consistent with previous touching bottom incident.

The hull plating in way of side water strakes and bottom was found in apparent satisfactory condition. The only exception was the light set-ins on the bottom plating in way of DBT no. 3, as described above.

5. Light bottom set-ins in way of DBT 3 port side

- DBTank 3: on the assumption that the light set-ins on the bottom plating are not recorded in ship's class records (either as a condition or memoranda) they should be brought to class attention and be dealt with as/if necessary.
- All Double bottom tanks: condition of plating underneath the sounding pipes have to be closely examined and striker plates fitted where missing.
- All Side ballast tanks and void spaces: Apparently heavily corroded areas, particularly in way of floors/bulkheads and girder lower parts, must be cleared (blasting will be desired) and exposed plating underneath to be again gauged in order to ascertain actual condition and assess the requirement of steel renewals

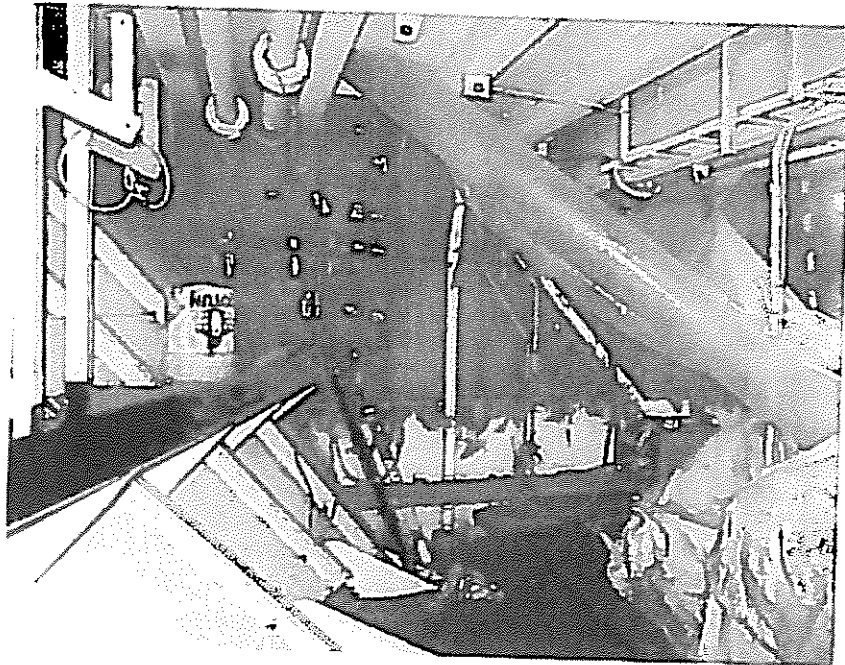
FP: Steel surfaces found generally rusty and/or corroded at places (coating non-existent and anodic protection not fitted) but apparently free of any excessive thinning or wastage. Steel renewal of large section of collision bulkhead noted at completion stage.

8. Bow thruster space looking at the renewed section of collision bulkhead

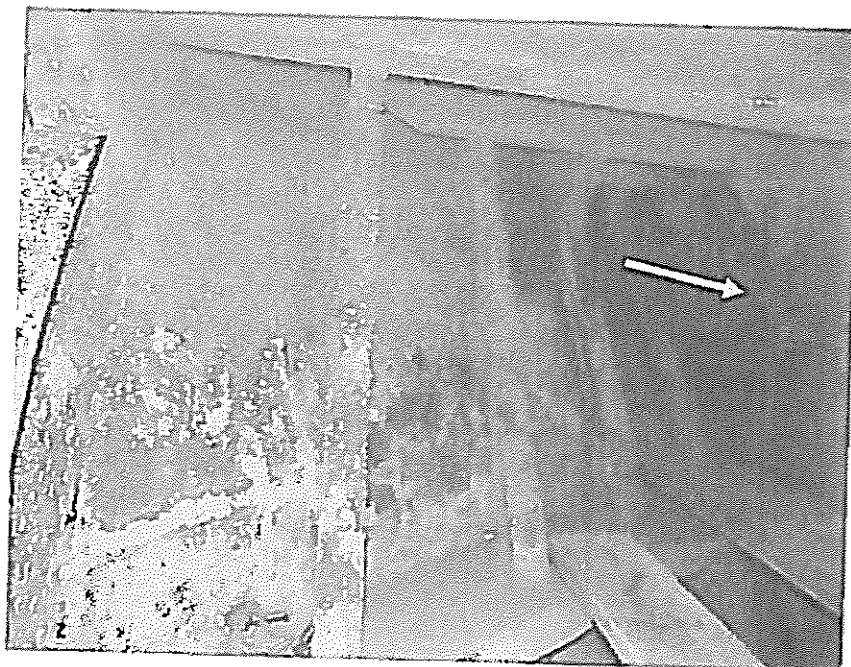
9. FPT stbd side shell plating and framing in rusty condition. Location of renewed section of collision bulkhead arrowed

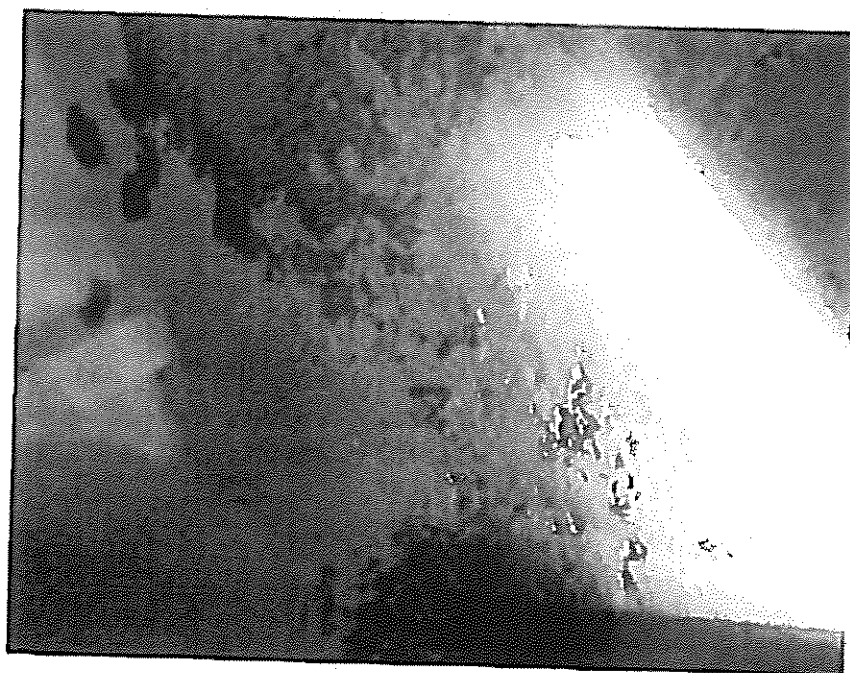
The extent of corrosion appeared to be worst in DBT no. 2 where the longitudinal center-line girder was additionally found to exhibit corrosion holes at three locations along its lower part (at connection to bottom plating). Further, all transverse floors/frames in this tank were found with apparent deep pitting over almost their entire width and height.

10. DBT2 pitting on transverse floor plating

- DBTank 2, 3 and 4: Apparently heavily corroded areas, particularly in way of floors/bulkheads and girder lower parts, have to be cleared (blasting will be desired) and exposed plating underneath to be again gauged in order to ascertain actual condition and assess the requirement of steel renewals. Same also applies for the apparent deep pitting noted on all floors in DBTank no. 2.

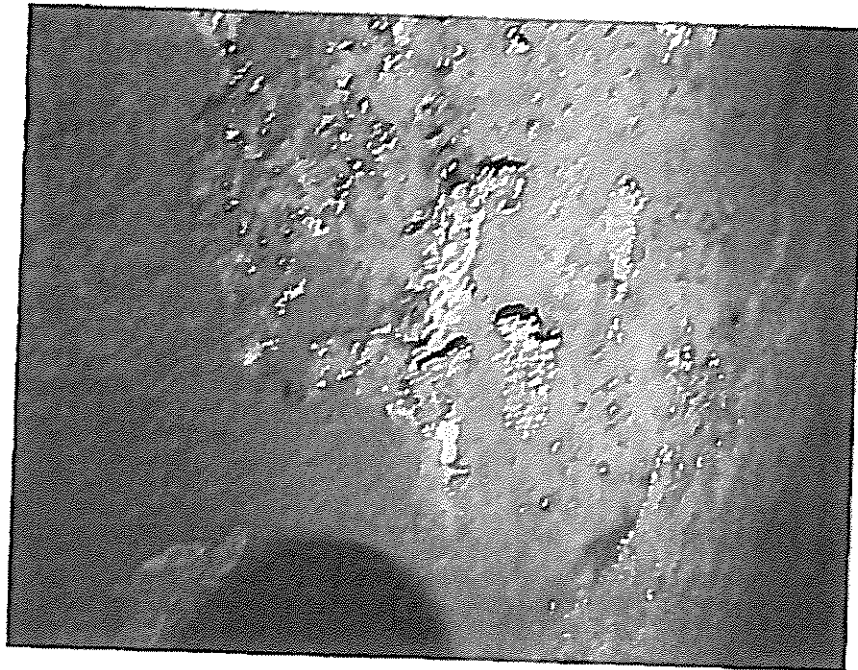
11. As above

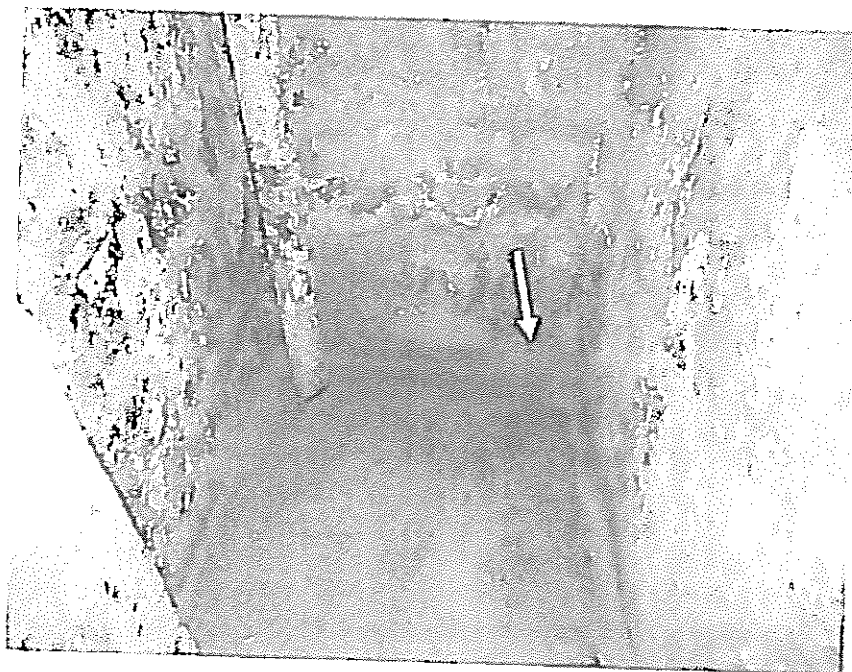
12. DBT 2 heavily corroded and holed lower part of centerline girder (arrowed)

Renewal as necessary of the corrosion holed longitudinal girder in DBT 2 required immediate attention.

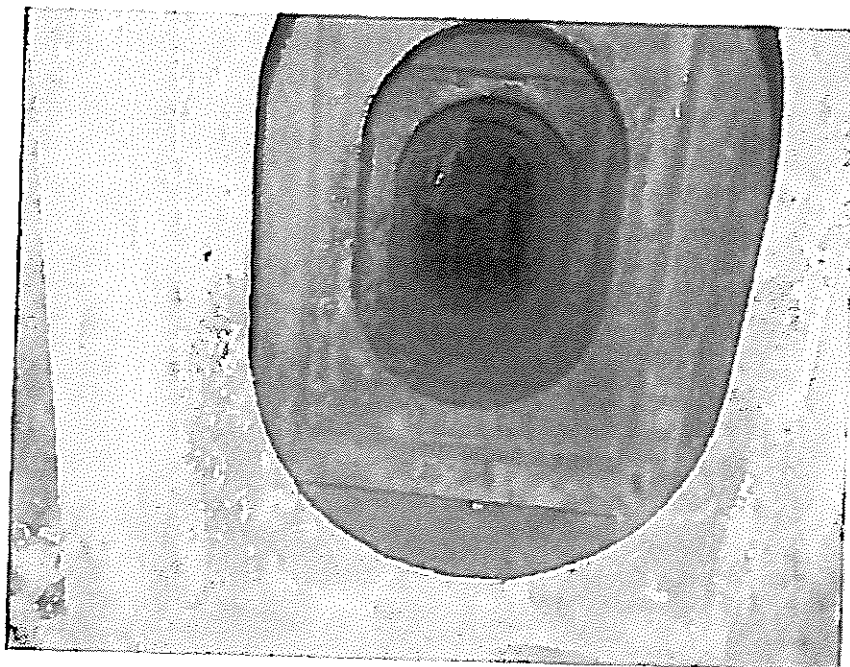
13. DBT2 transverse floors in rusty condition

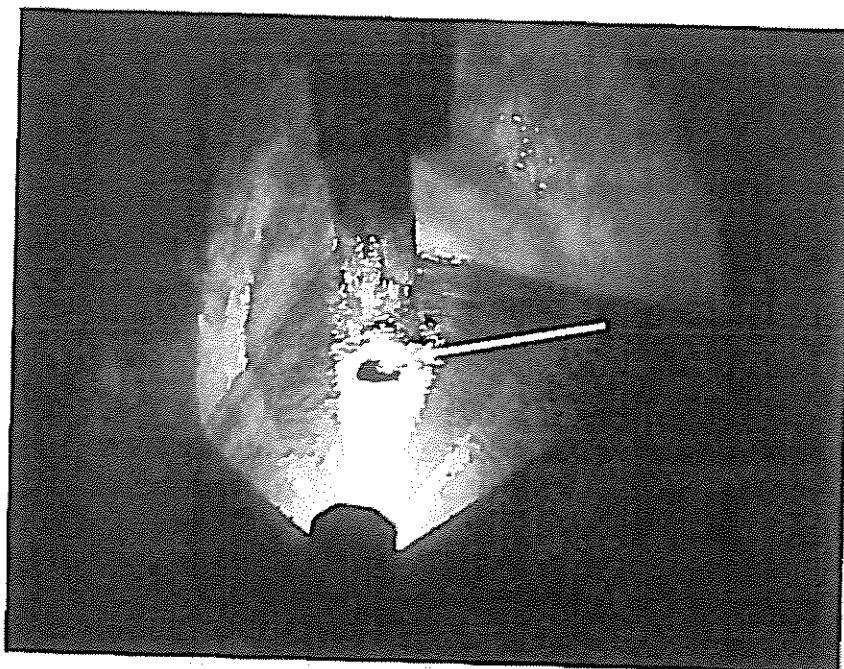
Some concern was also raised on the condition of bottom plating beneath the sounding pipes in DBT 2 and 3 where striker plates were missing and wear in the form of "craters" had been formed.

14. DBT 2 crater formed on bottom plating below the sounding pipe due to missing striker plate

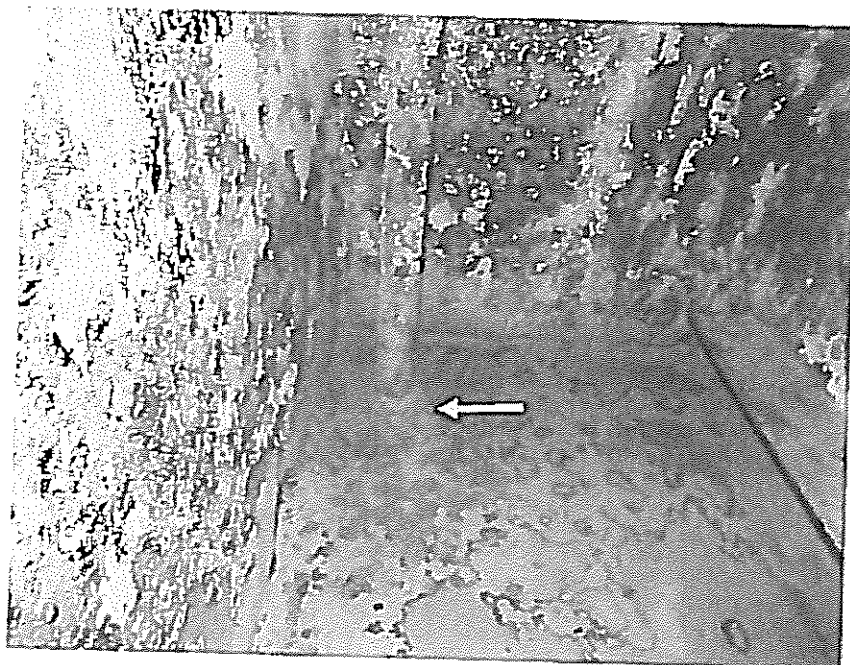
15. DBT 3 heavily corroded steel surfaces around sounding pipe. Striker plate also missing from bottom plating below the pipe (arrowed)

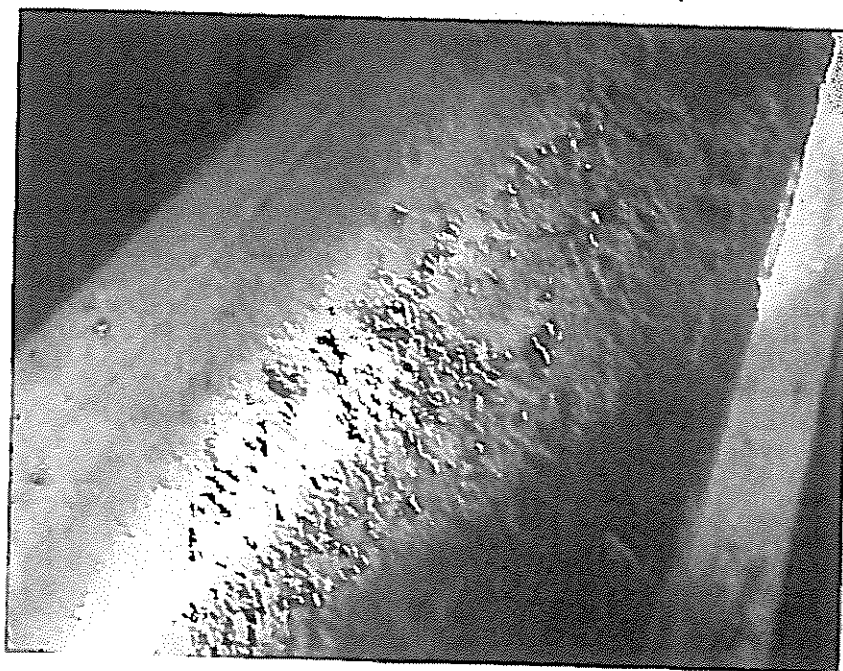
Pitting was apparent on the bottom plating in DBTank no. 3.

16. DBT 3 pitting on bottom plating

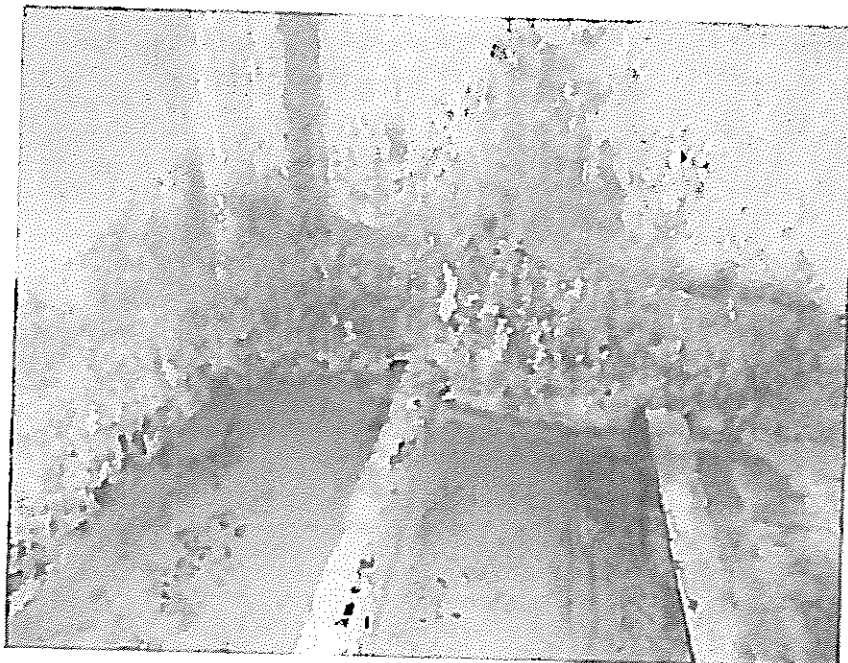
17. DBT 4 corroded steel surfaces

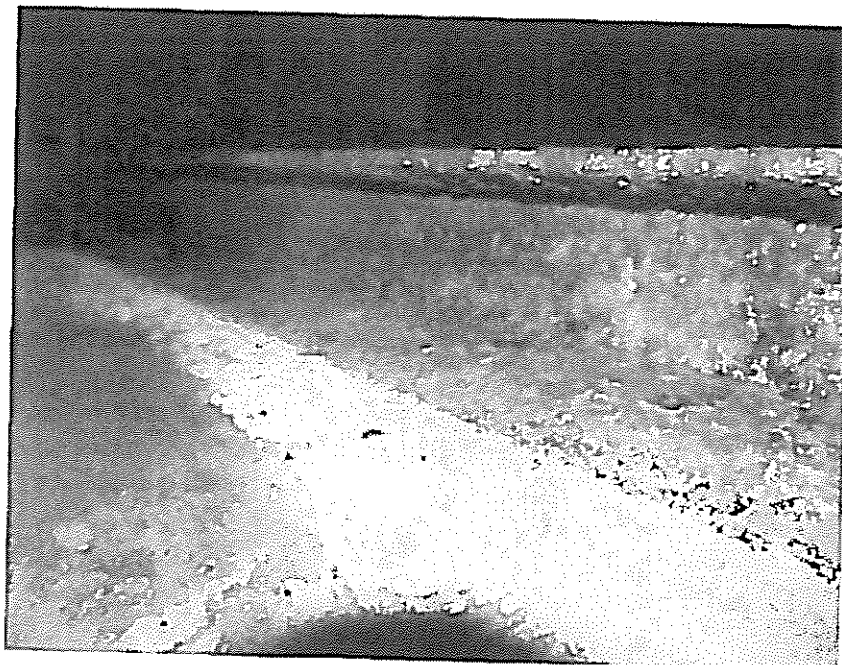
18. DBT 4 corroded bottom longitudinal

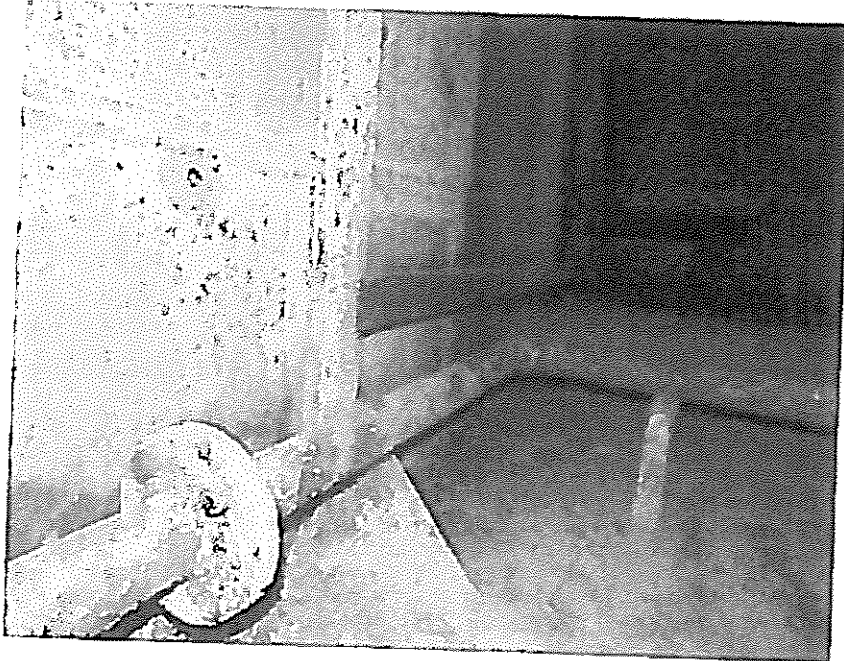
19. DBT 5 corroded lower part

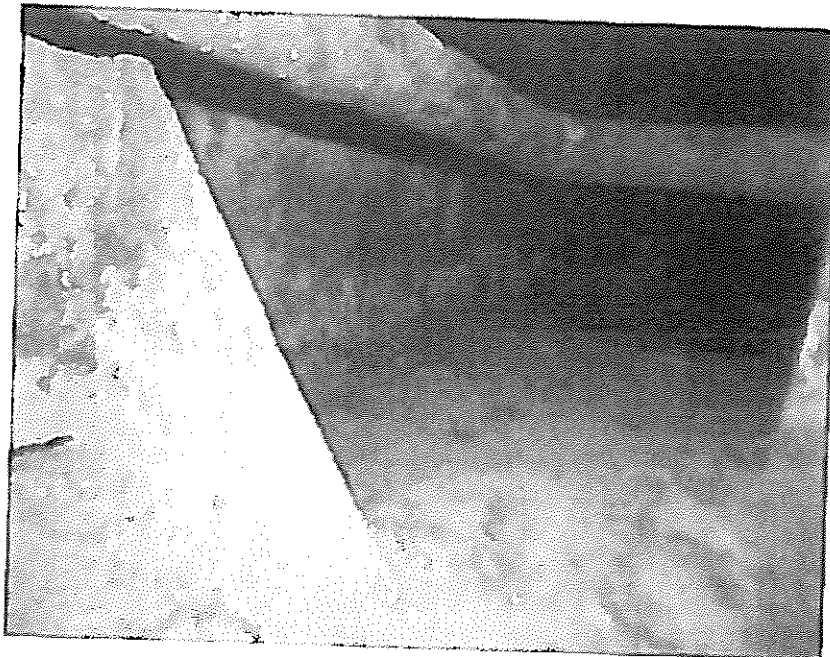
20. As above

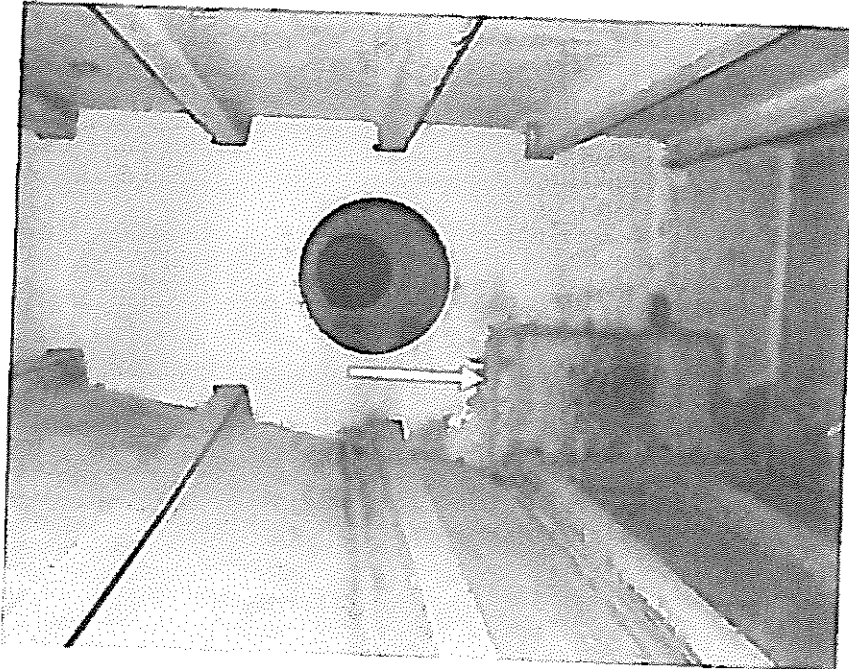
Previous localised steel renewals in way of transverse floors/bulkheads and longitudinal girders (insert plates) were also apparent at places in way of DBT 3, 4 and 5, mainly towards the centreline/keel area. This may be indicative of repairs on account of a grounding/touching bottom incident in the past.

21. DBT 5 previous Insert repair in way of transverse frame/floor (arrowed)

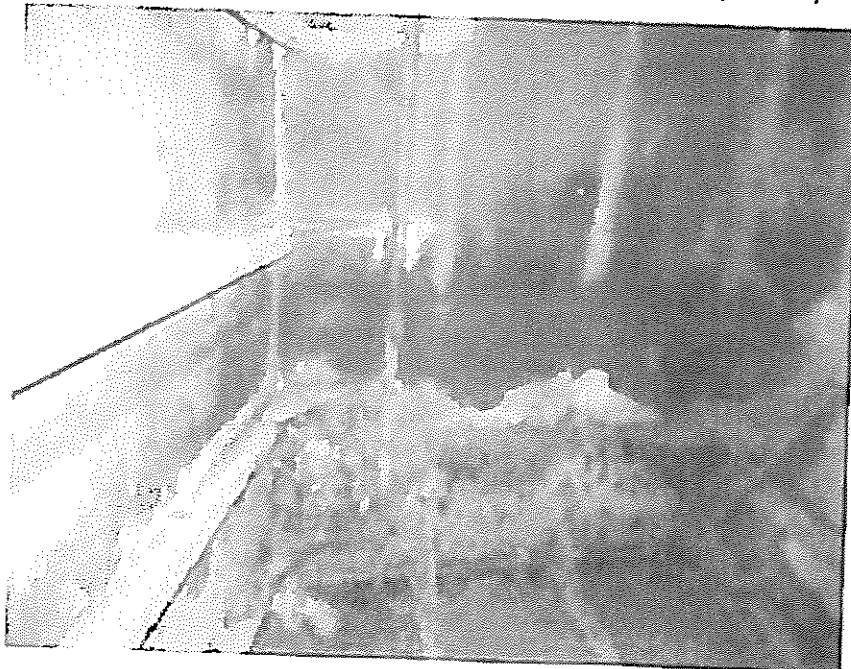
Attention is required in the lower part of the tanks (particularly in tank nos. 2 and 3 and to a lesser extent in tank no. 4) where extensive corrosion and/or pitting was present along the bottom plating, side shell, bulkheads and frames.

22. Side ballast tank 2P with signs of corrosion at lower part of bulkheads, sides and bottom structure.

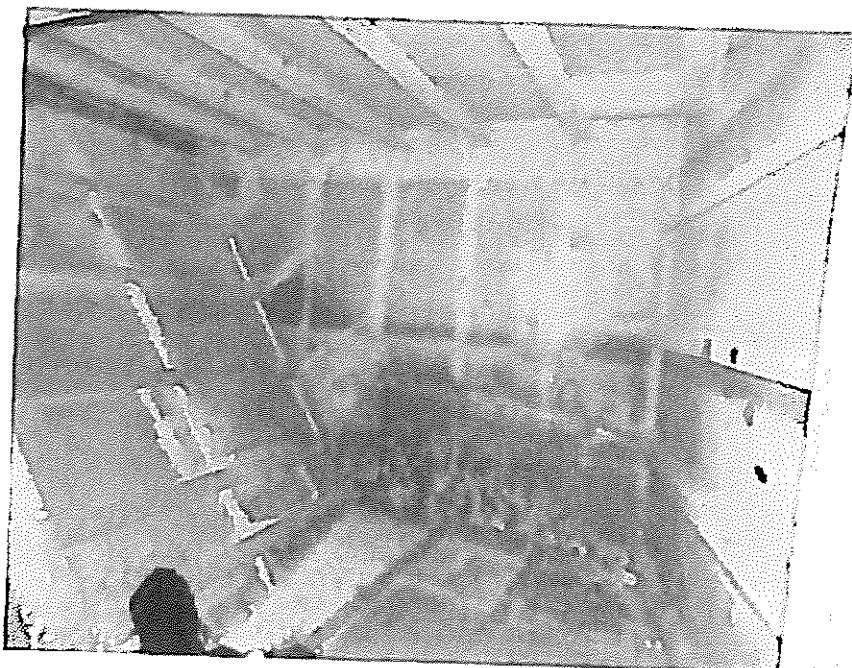
23. Side ballast 2S with signs of corrosion at lower part of bulkheads, sides and bottom structure

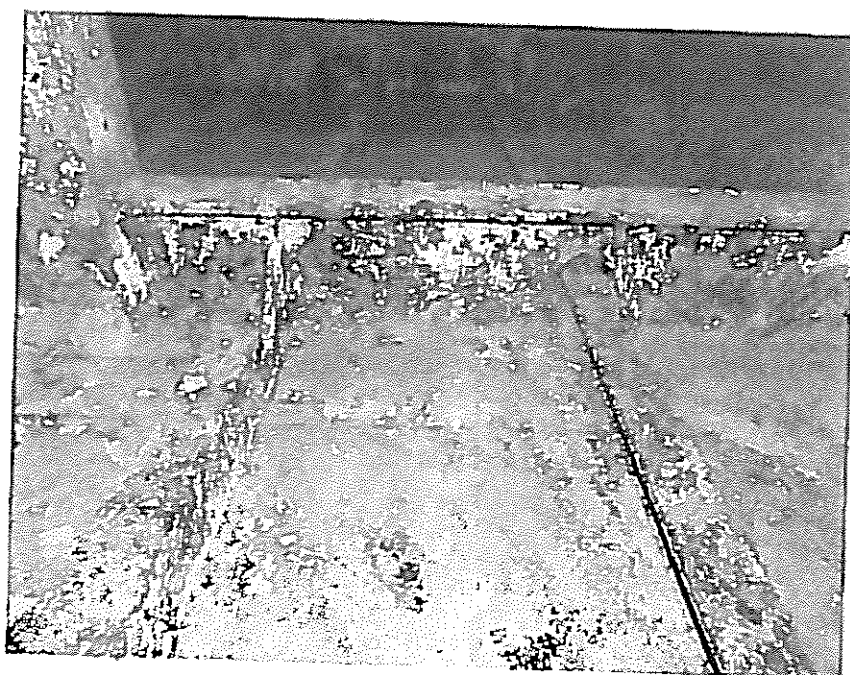
24. Side ballast tank no. 2S as above but under closer view of bottom framing showing the nature of corrosion

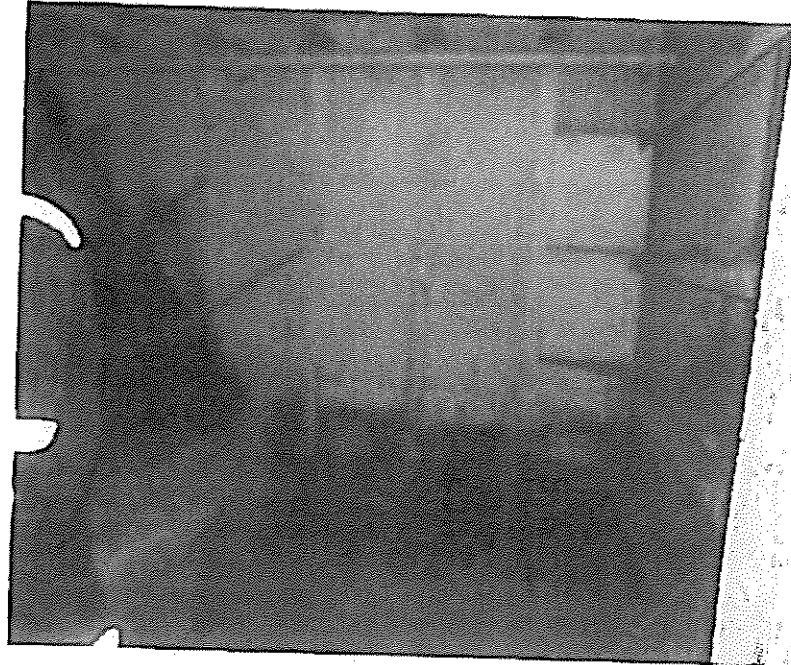
25. Side ballast tank 3P with signs of corrosion at lower part of bulkheads, sides and bottom structure

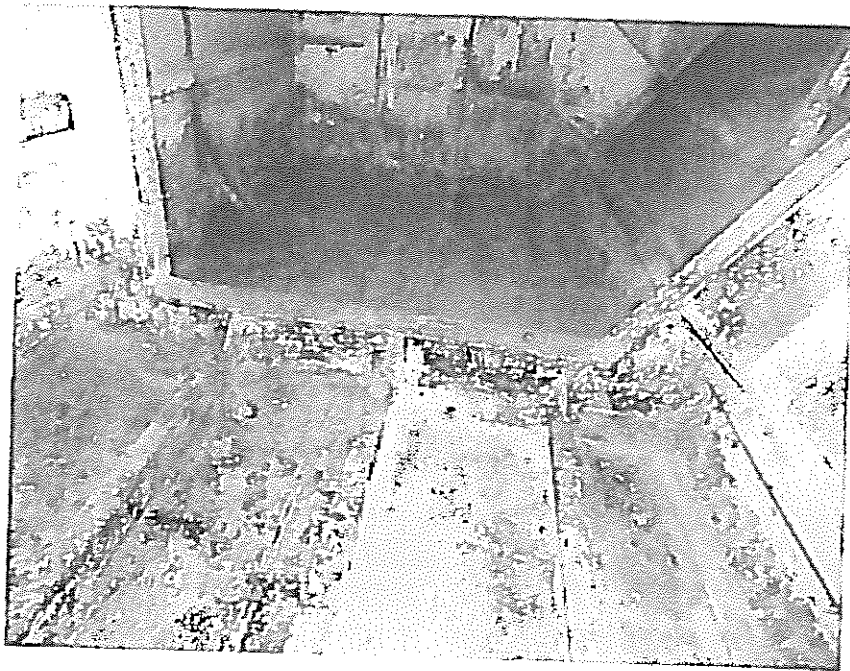
26. Side ballast tank 35 with signs of corrosion at lower part of bulkheads, sides and bottom structure

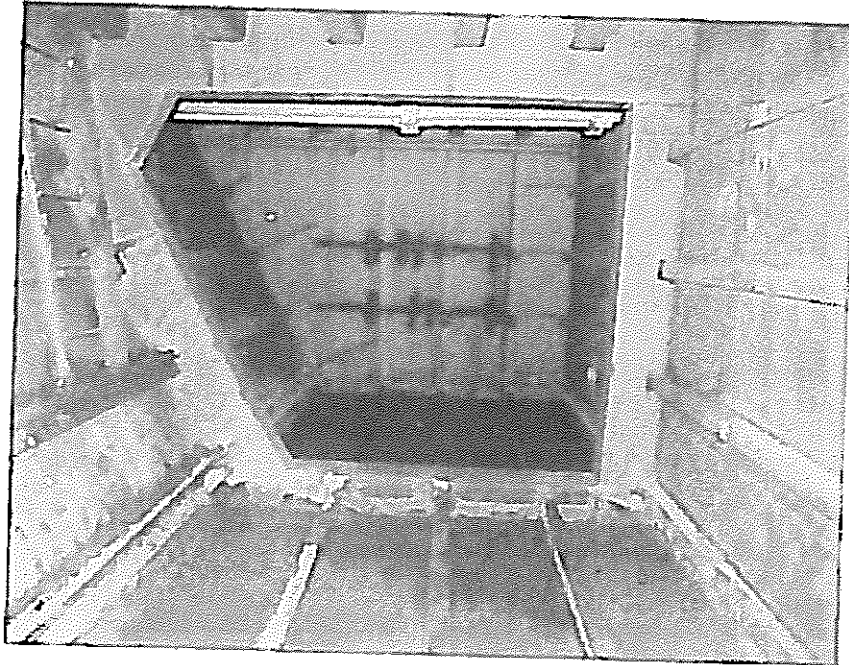
27. Side ballast 4P in better condition (coating generally intact)

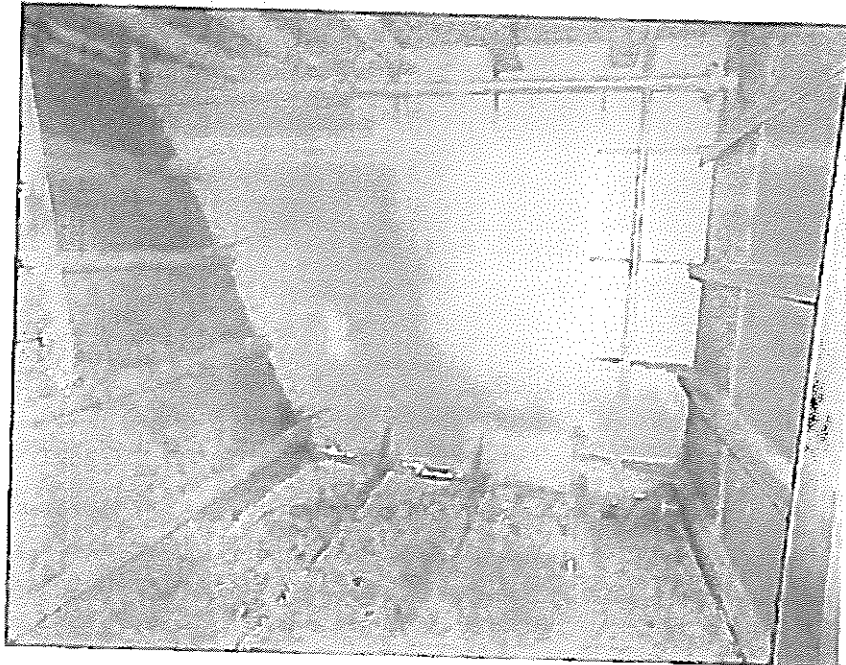
28. Side ballast 4S in similar condition as 4P but with signs of advanced corrosion on bottom plating

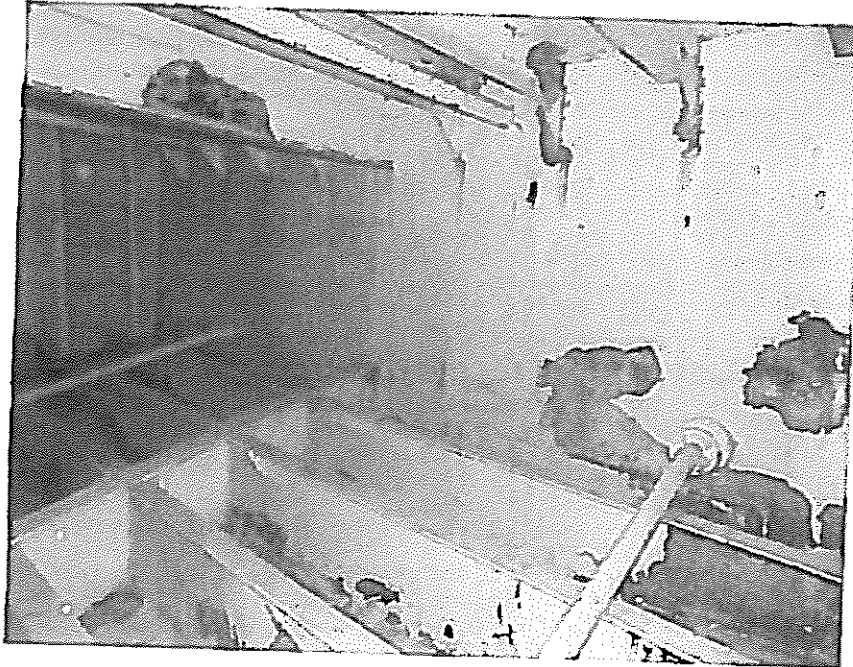
AP: Stbd tank found in similar condition as the FP. The center tank was in slightly better condition as coating was still in place although large flakes were seen to have detached at places and plating underneath was starting to rust.

29. Aft peak center in satisfactory condition but with localised peeling off/detachment of paint

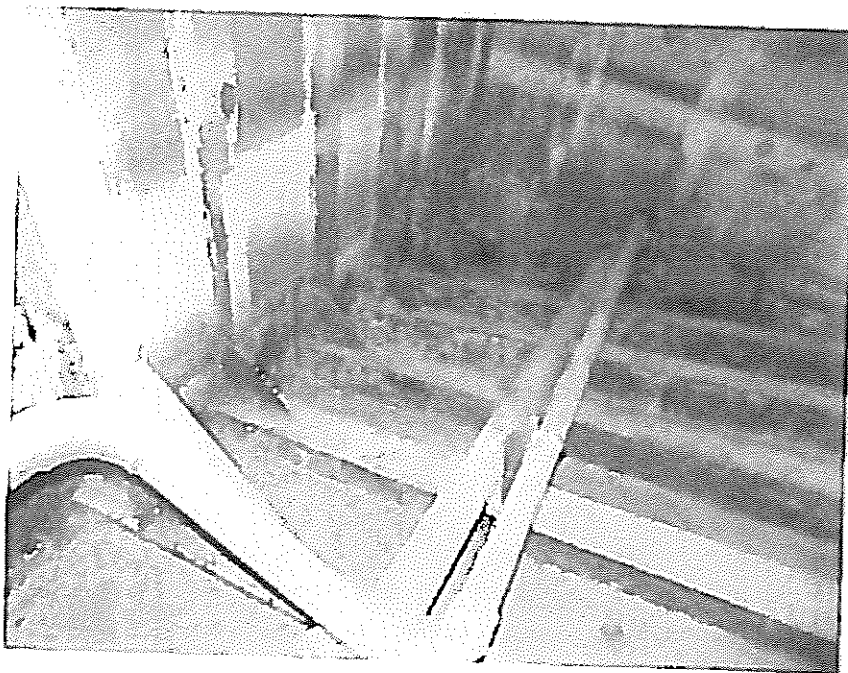
30. Aft peak port side in generally rusty and/or locally corroded condition

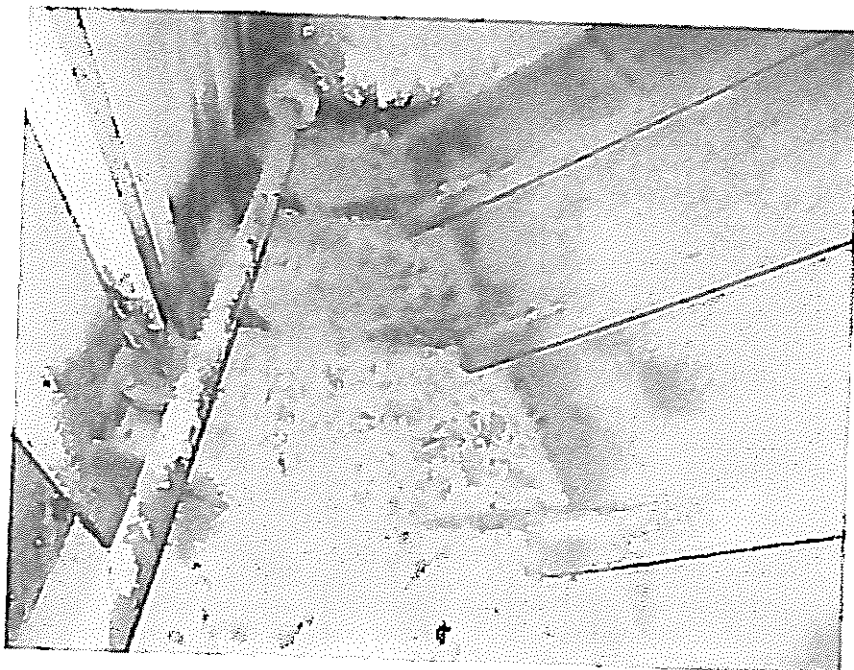
Attention is required in the lower part of the spaces (particularly in spaces 1, 2 and 3 and to a lesser extent in no. 4) where extensive corrosion and/or pitting was present along the floors, side and transverse bulkheads and frames.

31. Void space no. 1 corroded floor and lower part of bulkheads, side and frames

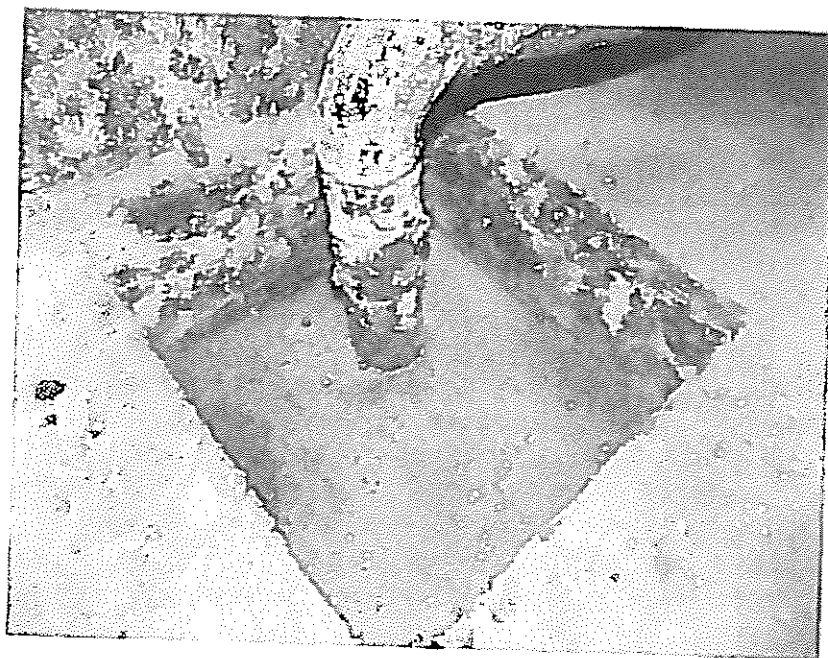
32. Void space no. 1 heavily corroded bilge well and piping

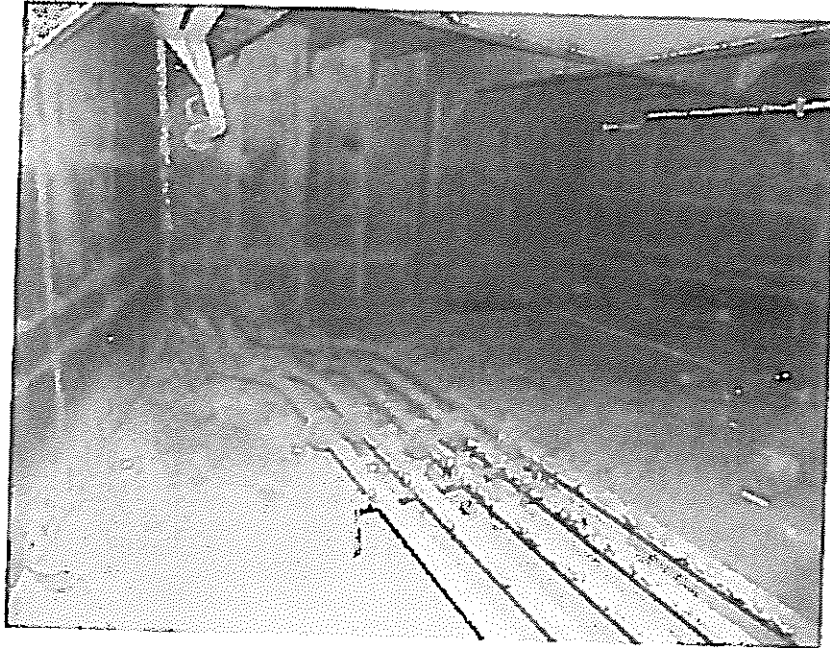
33. Void space no. 2 general view with corrosion affected bottom plating

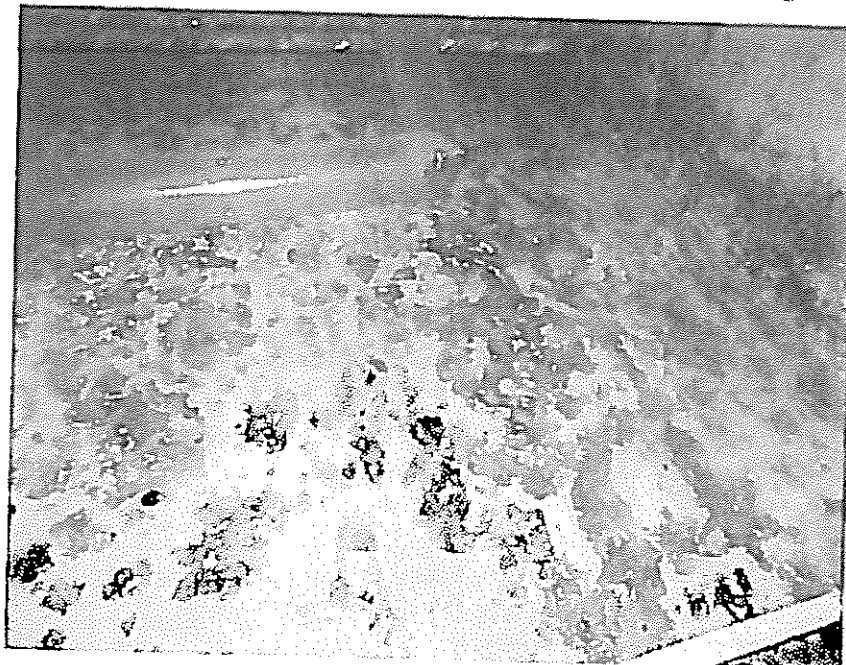
34. Void no. 3 corroded bottom plating

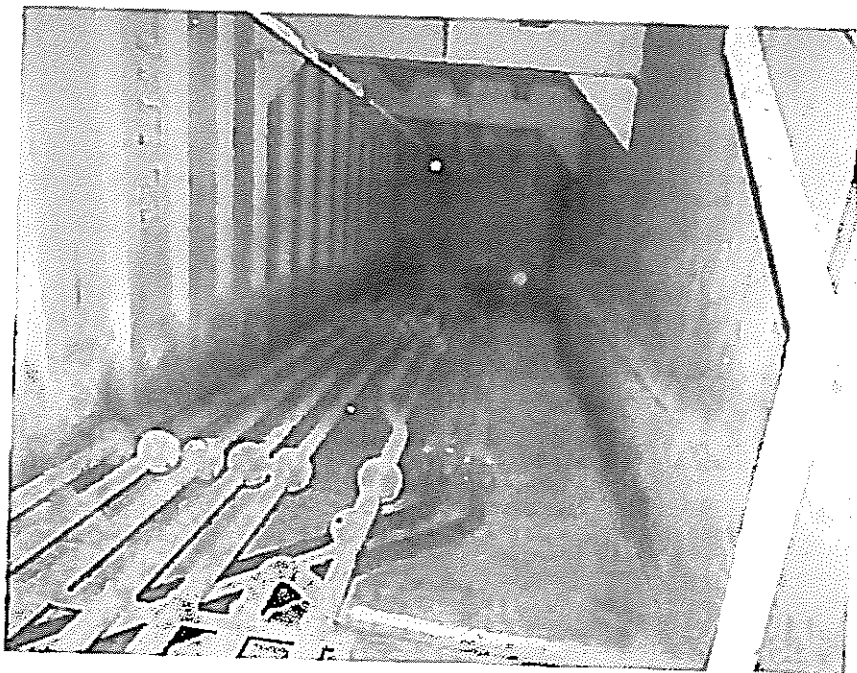
36. Void space no. 4 in similar condition as void no. 2
